TECHNICAL REPORT REMR-CO-3

CASE HISTORIES OF CORPS BREAKWATER AND JETTY STRUCTURES

Report 3
NORTH CENTRAL DIVISION

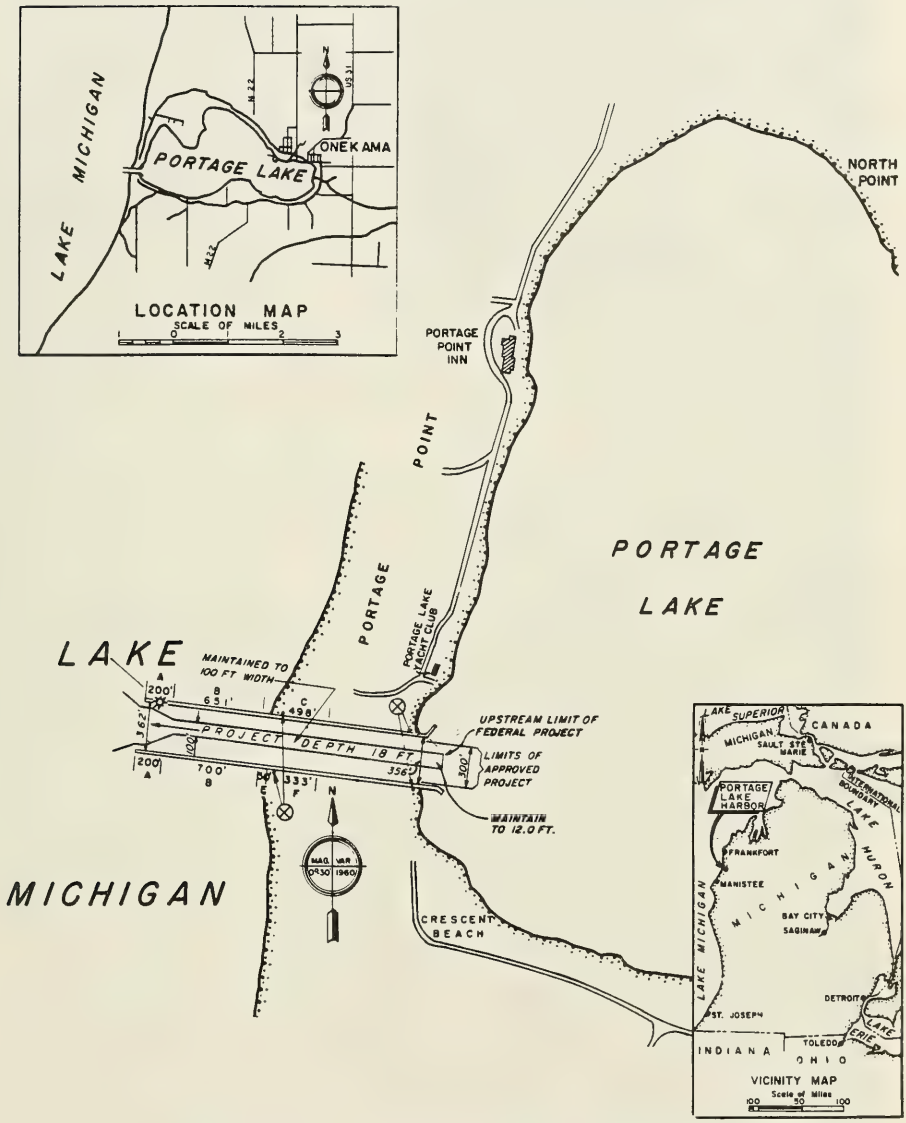
Figure 149. Portage Lake Harbor, Michigan

1980-1981	Riprap stone was placed around the heads of the north and south piers (Figure 149, Section A) during this period, and stone fill was replenished at various areas along both piers. After replenishment, the concrete caps were repaired.
1985	An inspection of the site indicated the piers were, in general, in fair condition. Settlement and cracking of the superstructure and fill stone loss indicate some substructure deterioration. Replenishment with large fill stone has been recommended along with additional riprap installation. An aerial view of Portage Lake Harbor piers is shown in Figure 151.

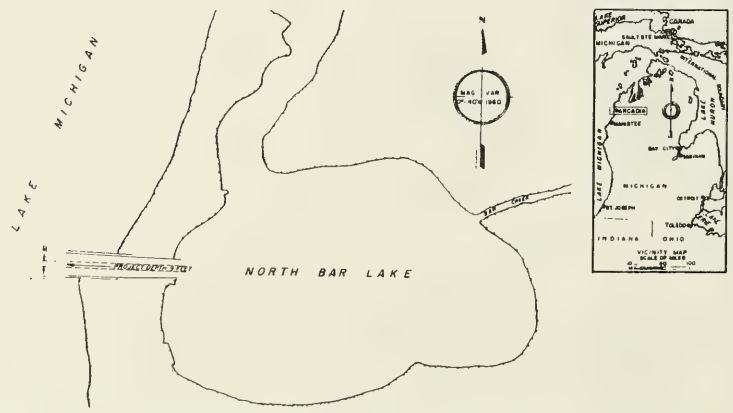
Figure 152. Arcadia Harbor, Michigan

1985	An inspection of the site indicated settled and/or washed out stone in numerous areas of the north pier. Water is washing through the voids of the structure, and three areas are nearly breached. The steel sheet-pile cell at the head of the south pier is completely broken out, and most of the grout cap along the entire length of the pier is missing with stone being washed out. The condition of the piers is very poor, and immediate reconstruction/rehabilitation has been recommended.

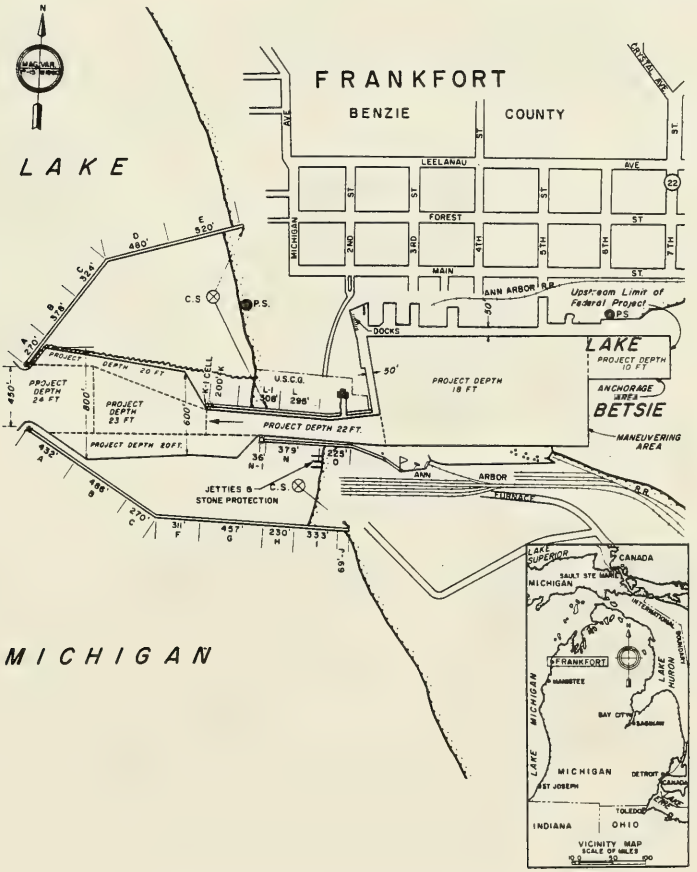
Figure 153. Frankfort Harbor, Michigan

Date(s)	Construction and Rehabilitation History
1984	Riprap stone was placed along the lakeward end of the south breakwater (Figure 153, Section A).
1985	An inspection of the structures indicated that the breakwaters were, generally, in fair condition. Their superstructures revealed cracks, settlement, and misalignment in areas, which indicate some substructure deterioration. Riprap was also needed in areas. The piers were considered in good condition during the inspection. An aerial view of the Frankfort Harbor structure is shown in Figure 157.

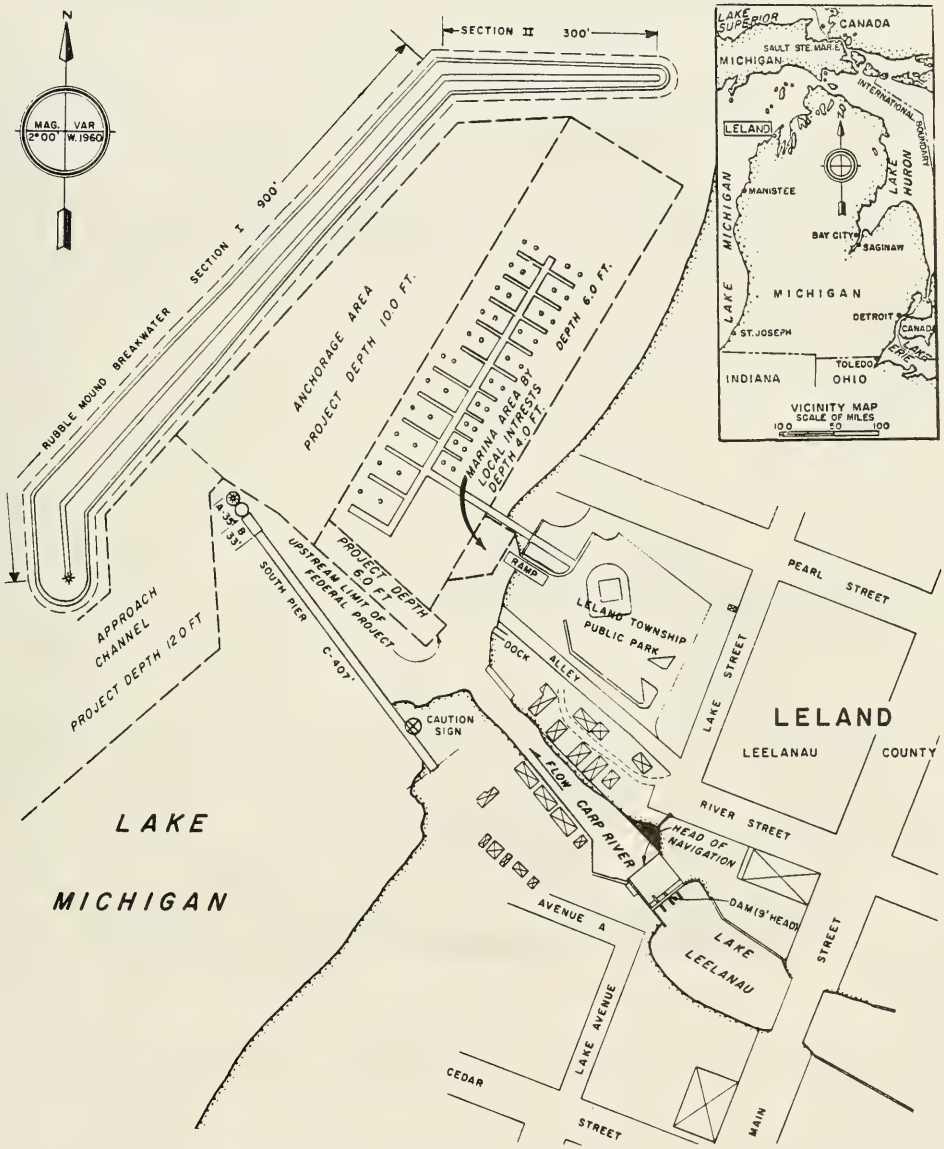
Figure 158. Leland Harbor, Michigan

1983	A site inspection of the harbor structures revealed them to be in fair to good condition. Settlement of cover stone and a portion of the north shore arm of the breakwater (Figure 158, Section II) was observed and has subsequently been repaired by the placement of additional stone. Stone settlement of portions of the entire south pier were observed and scheduled for replenishment.
1985	The structures are currently considered to be in good condition.

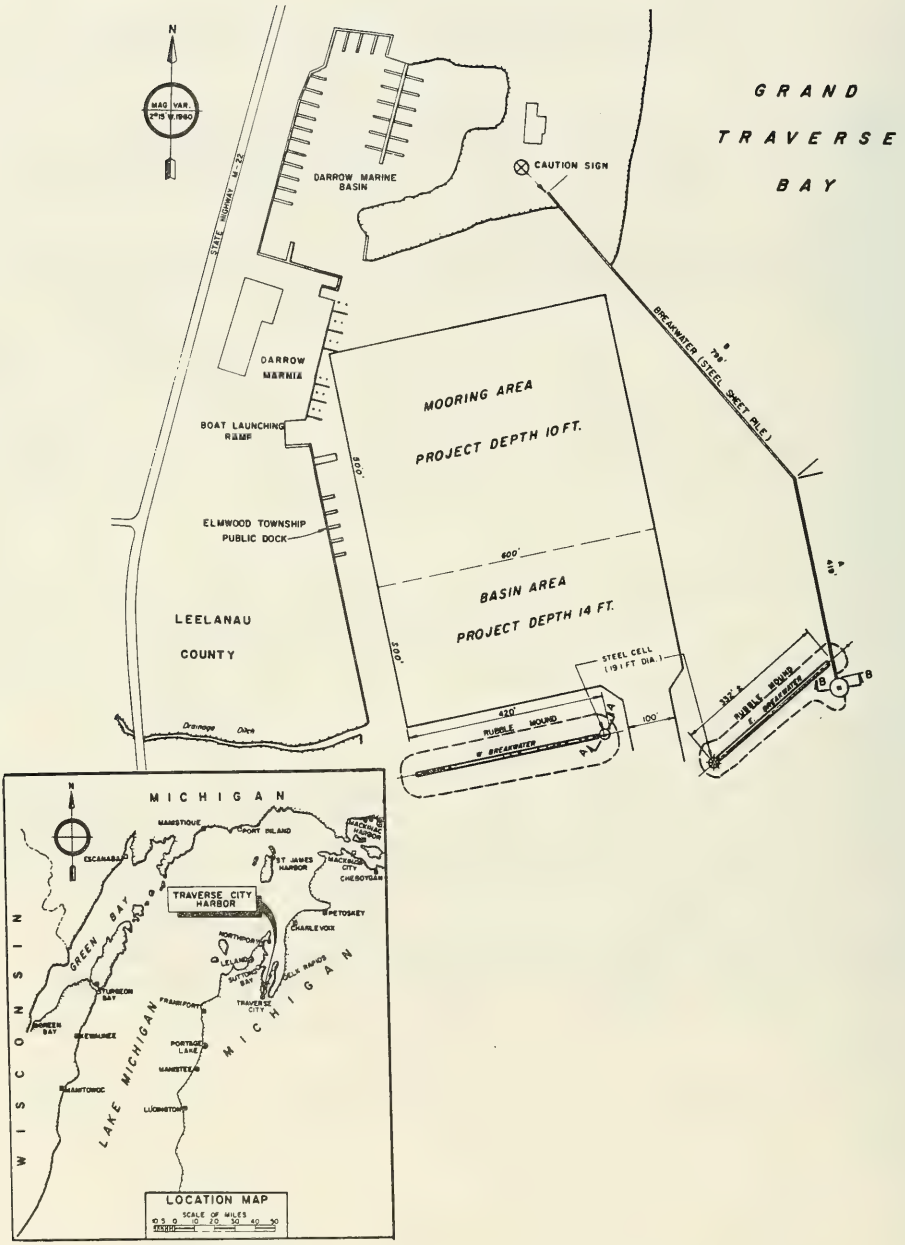
Figure 160. Greilickville Harbor, Michigan

1976	Stone was placed into a washed out area of the east end of the east breakwater (Figure 160).
1979	Stone was placed along both sides of the steel sheet-pile breakwater (Figure 160, Sections A and B) to reduce scouring and maintain structure stability.
1985	A site inspection of the breakwaters indicated that the rubble-mound east and west breakwaters were deteriorating slightly, with stones cracking and breaking into smaller pieces as a result of the low-grade limestone used in initial construction. Rehabilitation with sounder and slightly larger cover stones has been recommended. The breakwaters, however, were considered to be in good stable condition. An aerial photo of Greilickville Harbor breakwaters is shown in Figure 162.
1986	Traverse City Harbor was renamed "Greilickville Harbor," on 17 October 1986, in the 99th Congress, 2nd Session, Title XIII, Section 1304.

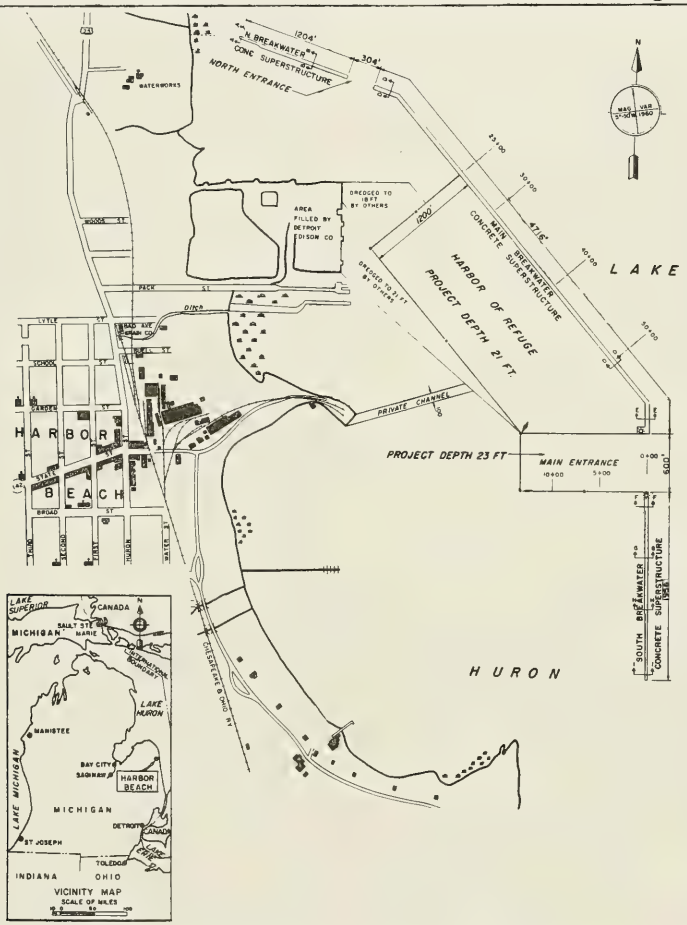
Figure 192. Harbor Beach, Michigan

Date(s)	Construction and Rehabilitation History
1981	Riprap was replenished along portions of the north breakwater, and cracks in the superstructure were repaired.
1985	An inspection of the site indicated the structures are in need of major rehabilitation. The timber cribbing of the substructures is collapsing under the weight of the concrete superstructures resulting in shifting and cracking of the superstructure. The breakwaters are considered to be in poor condition, and major rehabilitation has been recommended for the harbor to maintain its protective status. An aerial view of the Harbor Beach breakwaters is shown in Figure 194.

1916-1919	Riprap was placed on the lakeside of the main breakwater (Figure 193, Cross Sections D-D and E-E). It was placed on a 1-V:1.5-H slope with a crest ranging from about +3 ft lwd (Cross Section D-D) to +6.5 ft lwd (Cross Section E-E).
1921	Riprap was placed on each side of the south breakwater (Figure 193, Cross Sections F-F through I-I). The crest of the riprap on the lakeside was +8.0 ft lwd, and on the harbor side it was at an el of +3.5 ft lwd.
1925-1926	Riprap was placed on the lakeside of a portion of the north breakwater (Figure 193, Cross Section B-B) to an el of about +3.5 ft lwd.
1966	Rehabilitation of the south end of the main breakwater (Figure 192, Cross Section E-E) was performed. Work consisted of replenishing stone fill and repairing cracks in the substructures. Cost of the repairs was about $172,000.
1971	Rehabilitation of portions of the south breakwater (Figure 192, Cross Sections F-F through H-H) was completed. Riprap protection which included a total of approximately 38,500 tons of stone (ranging from 6 to 15 tons each) was performed for about $676,000.

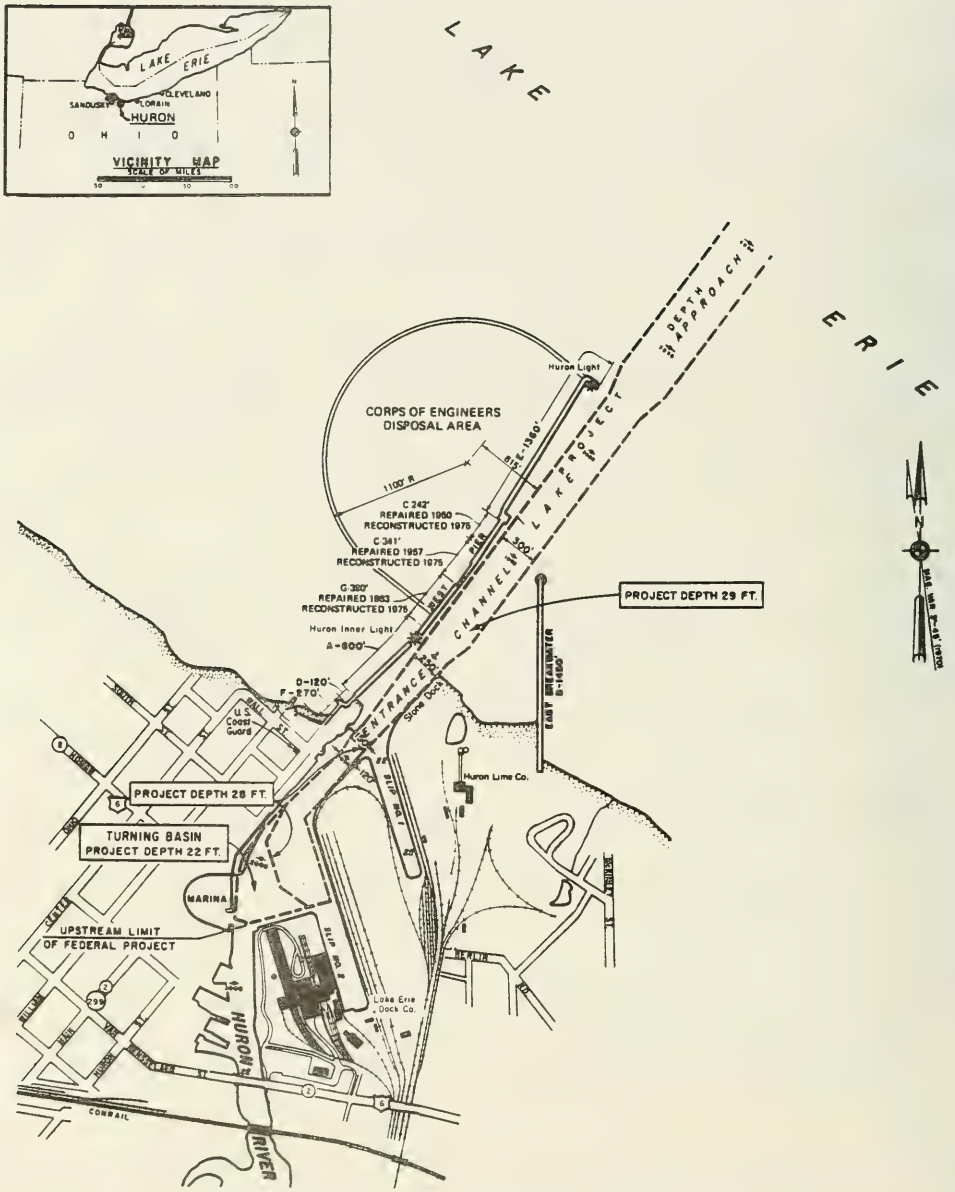
Figure 210. Huron Harbor, Ohio

1984	Many repairs have been performed during the structure's lifetime, and they are considered to be in fair condition. An aerial photo of the Huron Harbor structures is shown in Figure 213.

Date(s)	Construction and Rehabilitation History
1827-1831	Construction of an 800-ft-long west pier (Figure 210, Section A) was completed. The pier was a 20-ft-wide stone-filled timber crib structure (Figure 211, Section A).
1891-1894	A 973-ft-long extension of the west pier (Figure 210, Sections C and G) was completed. The extension consisted of a stone-filled timber crib structure that ranged from 16 to 20 ft in width (Figure 211, Section C).
1907-1908	Construction of a 1,450-ft-long rubble-mound east breakwater (Figure 210, Section B) was completed during this time. The breakwater had a crest width of 10 ft and an el of +10.3 ft lwd (Figure 212, Section B). Side slopes were 1V:2H on the lakeside and 1V:1.34 on the harbor side. A concrete and stone superstructure was installed on a portion of the west pier (Figures 210 and 211, Section C) also during this period of time. The crest el of the pier was +8.3 ft lwd.

1914	A 280-ft-long shoreward extension of the west pier (Figure 210, Sections D and F) was completed. The lakeward portion of the extension involved woodpilings driven about 15 ft apart and filled with stone (Figure 212, Section D). The extension was capped with larger stone (5-ton minimum) and had a crest el of about +6.0 ft lwd. The adjacent 160-ft-long shoreward portion of the extension (Figure 212, Section F) was a rubble-mound structure with a crest width of 5 ft and an el of +5 ft lwd. Side slopes were 1V:1H.
1925	A concrete superstructure was installed on an 800-ft-long portion of the west pier (Figures 210 and 211, Section A). The crest el of this portion of the pier was +6.3 ft lwd.
1930	The shoreward rubble-mound portion of the west pier constructed in 1914 (Figures 210 and 212, Section F) was repaired and extended shoreward an additional 110 ft.
1933-1934	A 1,360-ft-long rubble-mound extension of the west pier (Figure 210, Section E) was constructed during this period. The breakwater had a crest width of about 8 ft and an el of +8 ft lwd. Side slopes were 1V:1.3H (Figure 211, Section E). Armor stones with a minimum weight of 3 tons, and not less than 50 percent being 5 tons or more, were used.

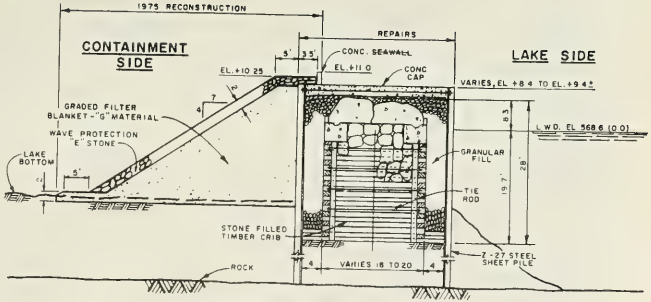
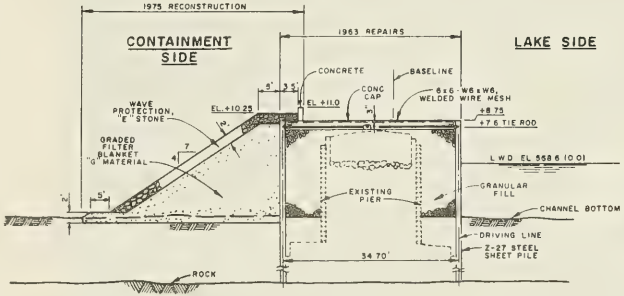
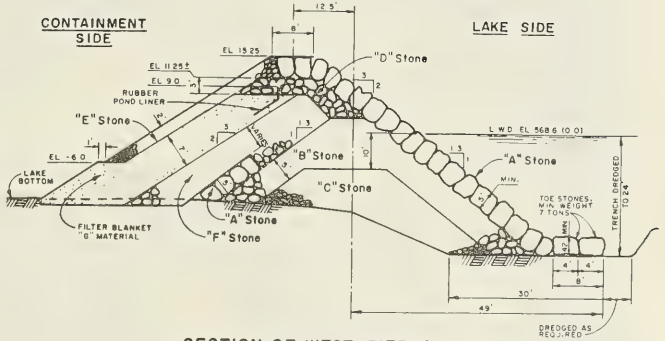
Figure 211. Typical pier cross sections, Huron Harbor, Ohio

SECTION OF WEST PIER AT -C-
(BUILT 1891 - 1894)
SUPERSTRUCTURE 1907-1908
REBUILT 242 FEET OF PIER 1950
REBUILT 341 FEET OF PIER 1957
FILTER BLANKET, WAVE PROTECTION AND SEAWALL ADDED IN 1975

SECTION OF REPAIRS TO 390 FEET OF WEST PIER MADE IN 1963 AT-G FILTER BLANKET, WAVE PROTECTION AND SEAWALL ADDED IN 1975

SECTION OF WEST PIER AT -E-
(BUILT 1933 - 1934)
RECONSTRUCTED 1975

1950	A 242-ft-long portion of the west pier was repaired by encasing it with steel sheetpiling (Figures 210 and 211, Section C). The voids between the sheetpiling and the existing structure were filled with

Date(s)	Construction and Rehabilitation History
	stone and a concrete cap was installed. The width of the pier varied from 24 to 28 ft, and the crest el ranged from +8.4 to +9.4 ft lwd.
1957	A 341-ft-long portion of the west pier was repaired (Figures 210 and 211, Section C) in the same manner as the 1950 repairs.
1963	A 390-ft-long portion of the west pier was repaired (Figures 210 and 211, Section G) in a manner similar to the 1950 and 1951 repairs. The structure width, however, was 34.7 ft, and the crest el was +8.75 ft.
1975	Reconstruction of the portion of the west pier adjacent to the Corps disposal area (Figure 210) was completed. The rubble- mound portion of the pier (Section E) was raised to an el of +15.25 ft lwd and had a crest el of 8 ft (Figure 211). The steel sheet-pile encased portion of the pier (Sections C and G) included the installation of stone adjacent to the containment side of the pier (Figure 211). The crest el of the stone structure was 10.25 ft lwd, and the crest width was 8.5 ft. A parapet was installed at an el of +11.0 ft on the encased structure adjacent to the stone crest.

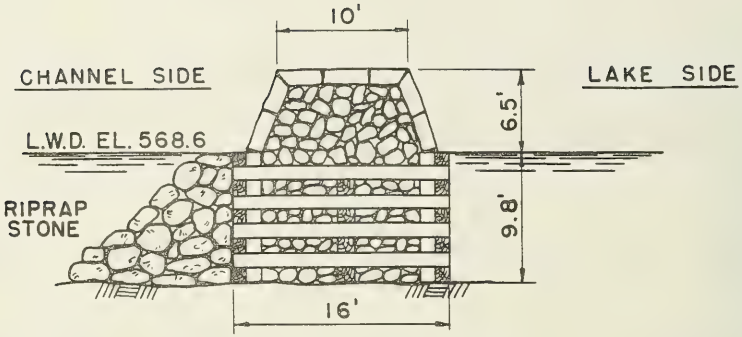
REHABILITATION OF 450 FEET OF WEST PIER AND 230 FEET OF EAST PIER INITIATED IN JUNE 1964 AND COMPLETED IN OCTOBER 1964. (TOP ELEVATION RAISED TO 6.5 FEET ABOVE L.W.D. AND RIPRAP STONE PLACED ON LAKE SIDE.)

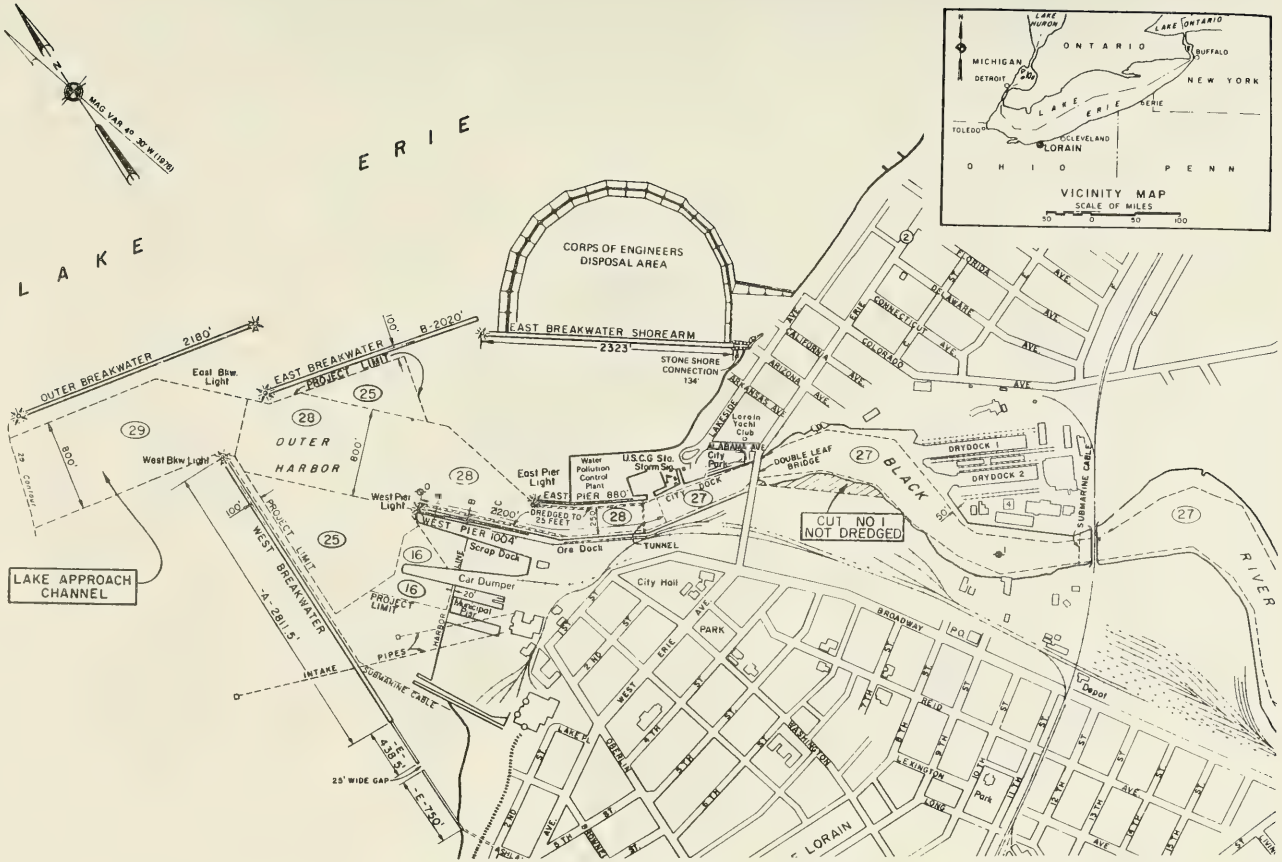
Figure 219. Lorain Harbor, Ohio

1977	A combination rubble-mound and steel sheet-pile dredge disposal dike was constructed and attached to the east breakwater shorearm.
1986	Recent site inspections indicated that portions of the rubble-mound stone sections of the structures show localized damage and considerable settlement. The structures are considered in fair condition, and no repairs are planned in the near future. An aerial photo of the Lorain Harbor structures is shown in Figure 222.

1963	Construction of a 2,457-ft-long east breakwater shore arm (Figure 219) was completed at a cost of about $2.7 million. The outer 2,323 ft was a granular-filled concrete capped cellular steel sheet-pile structure. The cells had a 35-ft diameter with a crest el of +10 ft lwd (Figure 221). Also included was a 134-ft-long rubble-mound shore connection (Figure 219). The rubble-mound portion had a crest el of +10 ft lwd and was capped with rectangular blocks (Figure 221).
1964-1965	The lakeward 995-ft portion of the east pier was removed leaving an 880-ft-long pier, and the lakeward 280-ft portion of the east breakwater was removed resulting in a structure 2,020 ft in length (Figure 219). A 2,180-ft-long granular-filled cellular steel sheet-pile outer breakwater was constructed (Figure 219). Cell diameters were 46.15 ft, and the breakwater was capped with concrete to an el of +10 ft lwd (Figure 221). Riprap toe protection also was placed adjacent to both sides of the breakwater. This modification was model tested (Wilson, Hudson, and Housley 1963).

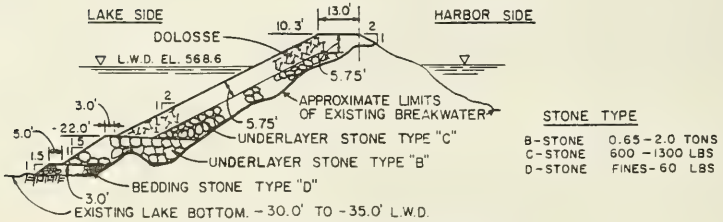
SECTION OF EAST BREAKWATER-D-
REHABILITATION OF PROTECTIVE CONCRETE ARMOR UNITS ON LAKE SIDE, 4400 FT. WAS DONE IN 1980

Date(s)	Construction and Rehabilitation History
1963	Rehabilitation of 1,000 ft of the protective riprap slope on the lakeside of the west breakwater (Figures 226 and 227) was performed.
1979	Portions of the west breakwater were rehabilitated (Figure 229). The concrete cap was restored to its original height, and new armor stone was installed along the lakeside of the riprap slope. The eastern portion of the east breakwater was in poor condition during a site inspection.
1980	Rehabilitation of 4,400 ft of the eastern end of the east breakwater (Figure 226, Section D) was performed using 29,700 two-ton unreinforced dolos concrete armor units. Two layers of dolosse were placed on the lakeside of the trunk and around the head using a placement density of 161 dolosse per 25 lin ft of breakwater. The slope was 1V:2H. Model tests were not conducted prior to installation of the dolosse.
1982	Repair of the head of the east breakwater following a storm in April was completed using 200 two-ton unreinforced dolosse.

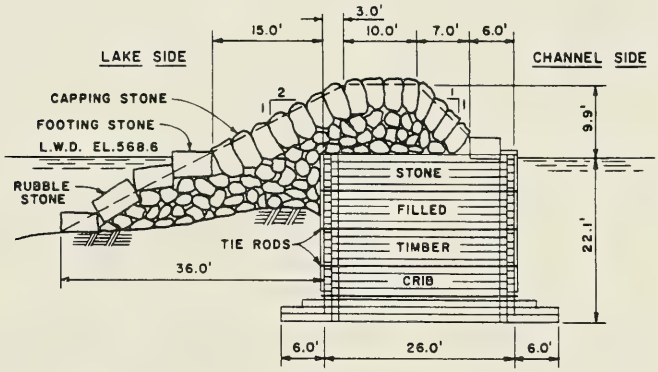
SECTION OF
WEST BREAKWATER-J
(BUILT 1905)
(REPAIRED 1925)

1925	Stone was placed over the cap and on the lakeside of the timber crib portion of the west breakwater (Figures 234 and 236, Section J). The stone was placed at an el of +9.9 ft lwd with a crest width of 10 ft and side slopes of 1V:2H.
1932	Construction of a 6,750-ft-long rubble-mound detached east breakwater (Figure 234, Section B) was completed. The breakwater had a crest el of +8.2 ft lwd and a width of 10 ft (Figure 235, Section B). Side slopes were 1V:1.5H and had a minimum weight of 3 tons.
1935	A 500-ft-long extension of the west breakwater (Figure 234, Section F) was completed. The extension consisted of a sand-filled cellular steel sheet-pile structure (Figure 235, Section F). The cells were 30 ft in diameter and capped with concrete at an el of +8.4 ft lwd. Riprap was placed on the channel side.
1939	Construction of a 500-ft-long west pier (Figure 234, Section D) was completed. The pier consisted of sand-filled cellular steel sheet-pile structures (Figure 235, Section D). The cell diameters were 34 ft, and they were capped with concrete at an el of +7.9 ft lwd.

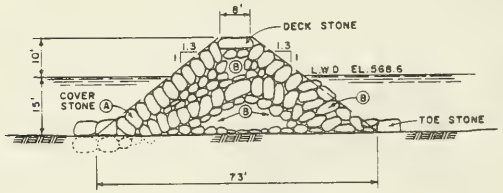
SECTION OF WEST BREAKWATER-I
(BUILT 1912-1917
REBUILT 1941-1954)

Date(s)	Construction and Rehabilitation History
	The west breakwater shore arm had a crest el of +8 ft lwd and a width of 10 ft and 1-V:1.3-H side slopes (Figure 248, Section H). Armor stone sizes were the same as those on the lakeward breakwater extensions.
1941-1954	Rehabilitation of a 1,251-ft-long portion of the west breakwater (Figure 246, Section I) was performed. The structure was built up with additional stone to a crest el of +10 ft lwd and a crest width of 8 ft (Figure 248, Section I). Side slopes of 1V:1.3H were used, and armor stone with a minimum weight of 3 tons and not less than 50 percent of 5 tons or more was placed.
1954-1960	A 1,552-ft-long portion of the west breakwater trunk was rehabilitated by the installation of additional stone to its original design (Figures 246 and 247, Section A).
1963-1964	Rehabilitation of a 600-ft-long portion of the west breakwater (Figures 246 and 247, Section A) and an 800-ft-long portion of the east breakwater (Figures 246 and 247, Sections B and C) was completed. The rubble-mound portions of the breakwaters were repaired by the installation of additional stone to original design specifications.

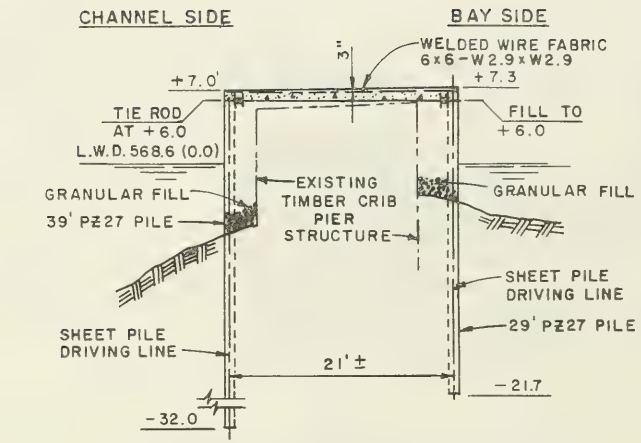
SECTION OF NORTH PIER-A

1979	A disposal dike was constructed adjacent to the south pier (Figure 253).
1984	Portions of the north pier were repaired (Figure 253, Sections A, F, and G). These piers were encased in steel sheetpiling. The voids between the sheetpiling and the existing timber cribs were granular filled, and the structure was recapped with concrete (Figure 255). The shoreward end of the north pier (Section A) was approximately 21 ft in width with a crest el of +7.3 ft lwd. The lakeward portions of the pier (Section F and G) were about 28 ft wide with an el of +9.8 ft lwd.
1986	The piers are presently considered to be in good condition. An aerial photo of the Erie Harbor piers prior to the construction of the disposal dike is shown in Figure 256.

REPAIRED 1984

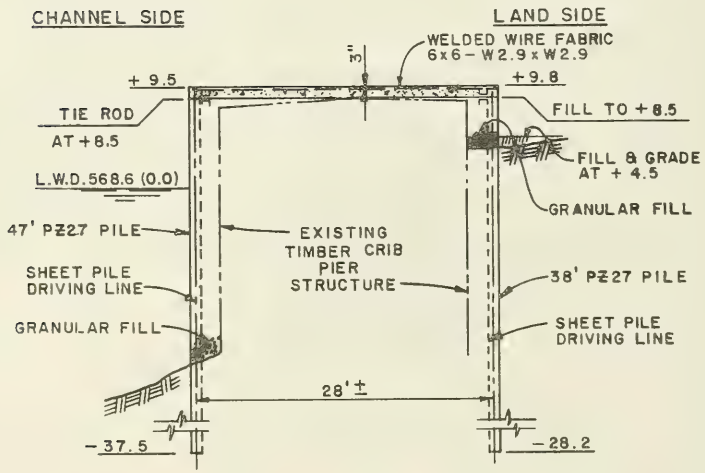
SECTION OF NORTH PIER-F-G

REPAIRED 1984

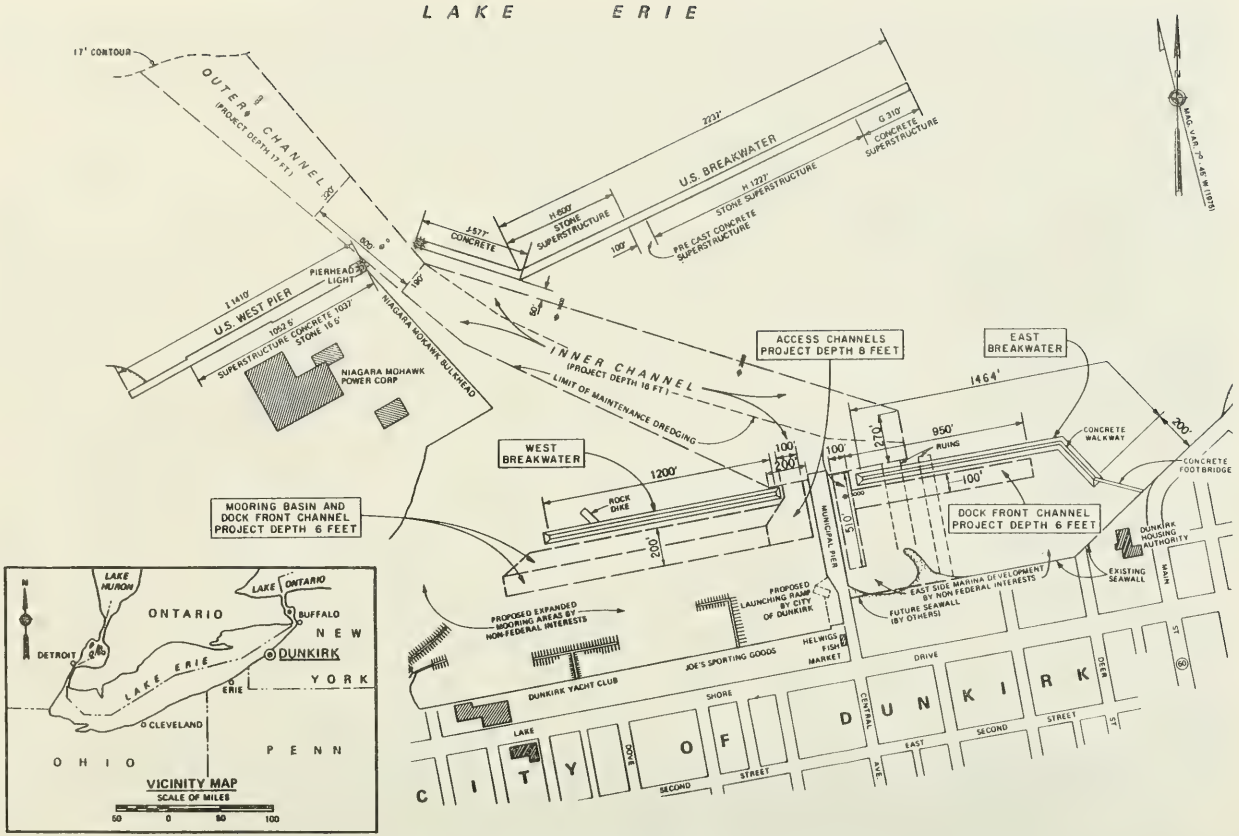
Figure 259. Dunkirk Harbor, New York

1986	The inner rubble-mound breakwaters presently are in good condition, and the west pier and outer breakwater are considered to be in fair condition. The concrete portions of the superstructure of the outer breakwater and pier show signs of spalling and slight separation at the joints; however, no immediate action is required. The stone superstructure portions of the outer breakwater seem to have settled lakeward in areas, and additional stone has been recommended to increase the height of the structure to its original design. An aerial view of the Dunkirk Harbor structures is shown in Figure 261.

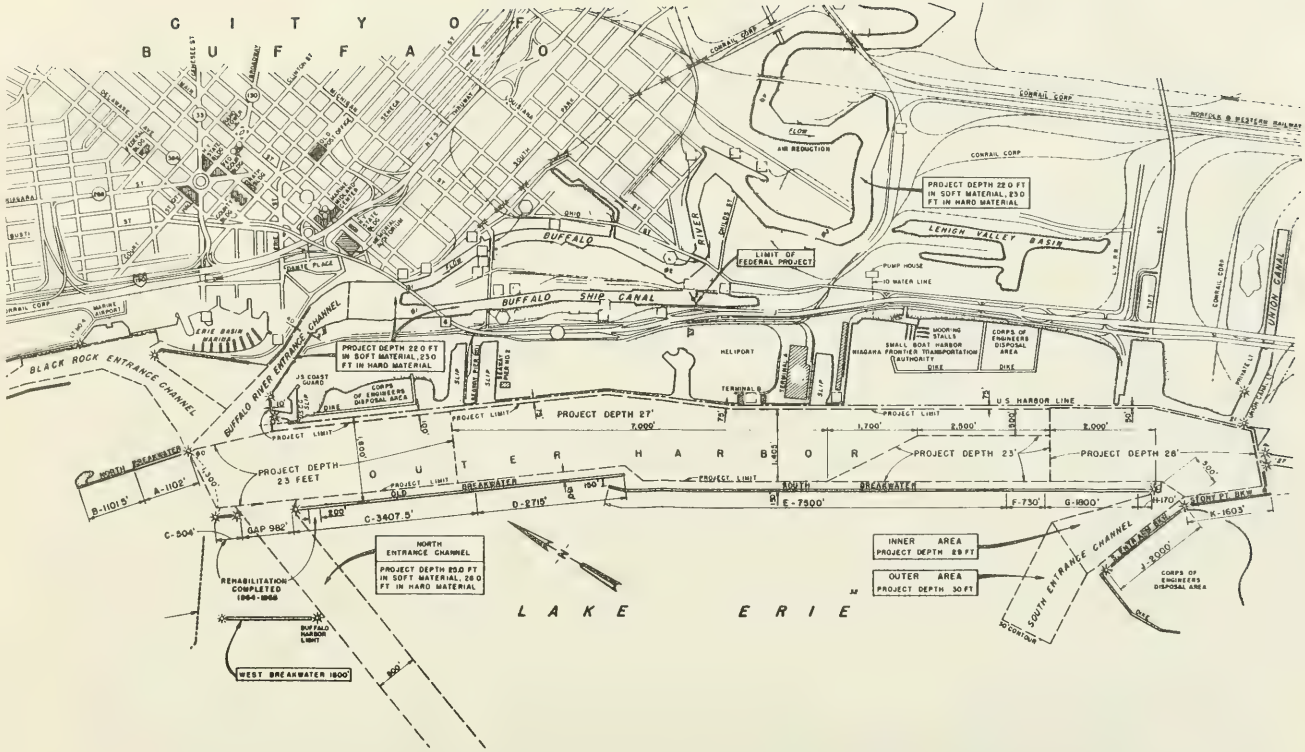
Figure 265. Buffalo Harbor, New York

1986	The breakwaters are presently considered to be in good to fair condition. There are isolated areas of settlement along the length of the Old Breakwater, the south breakwater, and the west breakwater. No immediate repairs are required, but the structures are being monitored for signs of accelerated deterioration. An aerial view of the Buffalo Harbor breakwaters is shown in Figure 270.

1964-1965	Rehabilitation of portions of the old breakwater (Figure 265) was completed. Repairs consisted of reconstruction of the stone slopes adjacent to the sea sides of the structures. The cost of improvements was about $220,000.
1977	A disposal dike was constructed adjacent to the south entrance arm breakwater (Figure 265).
1982	A major storm occurred in January with wind gusts reaching 75 mph, resulting in extraordinary sized storm waves. An inspection of the harbor breakwaters subsequent to the storm revealed damages to about 300 ft of the north breakwater. Concrete caps were dislodged, and core stone was exposed. Rehabilitation was recommended.
1983-1984	Recommended repairs with stone and concrete to about 300 ft north of the breakwater were completed for a cost of about $900,000. New armor stone ranging from 6 to 13 tons was utilized (Figure 269). The crest of the new stone was +13.5 ft lwd.

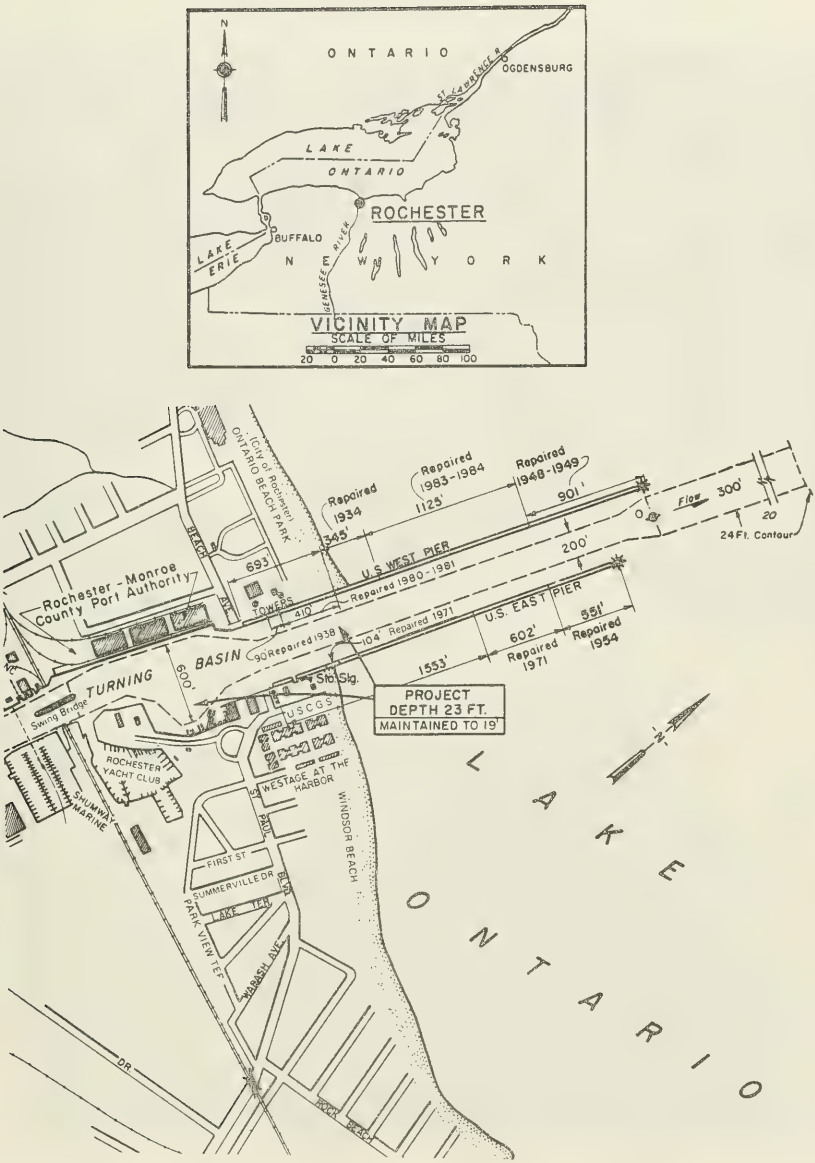
Figure 281. Rochester Harbor, New York

1986	The structures presently are in good condition with the exception of minor repairs needed on the shoreward ends of both piers. An aerial photo of the Rochester Harbor piers is shown in Figure 283.

1954	Rehabilitation of the lakeward 551-ft-long portion of the east pier was completed (Figure 281). The repairs were similar to those of the west pier completed during 1948-49 (Figure 282).
1971	Additional rehabilitation of the 706 ft of the east pier was completed (Figure 281). Repair methods consisted of parallel steel sheetpiling, granular fill, and a concrete cap, similar to that done previously (Figure 282).
1980-1981	Rehabilitation of a 410-ft-long portion (Figure 281) of the west pier was completed. Repairs consisted of the installation of parallel steel sheet-pile walls (on each side of the existing structure). Voids were granular filled, and the pier was capped with concrete. The crest el of the repaired structure was +7.5 ft lwd, and the pier width was 22 ft.
1983-1984	A 1,125-ft-long portion of the west pier (Figure 281) was rehabilitated. Repairs were similar to those done previously by encasing the existing structure in steel sheetpiling, filling the voids with granular fill, and capping the structure with concrete.

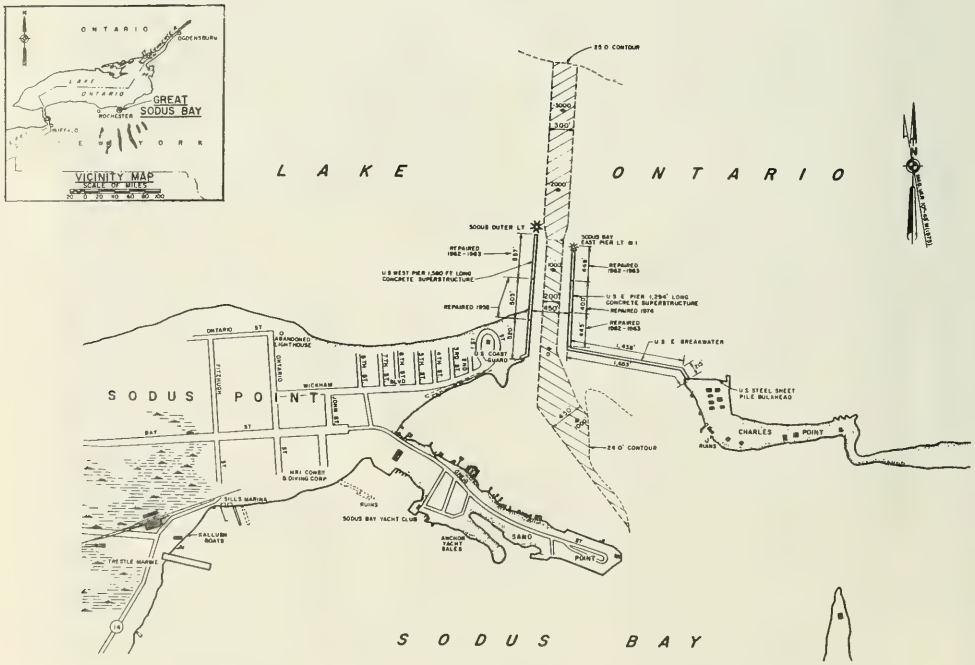
Figure 287. Great Sodus Bay Harbor, New York

Date(s)	Construction and Rehabilitation History
1986	The piers presently are in satisfactory condition, and no immediate repairs are required. The east breakwater, however, appears to have areas where undermining is prevalent and concrete is spalled. Repairs have been recommended. An aerial photo of the Great Sodus Bay Harbor structures is shown in Figure 289.

1958	A 503-ft-long portion of the west pier was repaired (Figure 287). The existing pier was encased with steel sheetpiling driven 27 ft apart. Voids were granular-filled, and the pier section was capped with concrete (Figure 288). The el of this portion of the pier was +8.7 ft lwd.
1962-1963	A 557-ft-long portion of the west pier and two portions (445 and 449 ft) of the east pier (Figure 287) were rehabilitated. Repairs were similar to those done on the west pier in 1958 (Figure 288). The els of these pier portions were +8.8 ft lwd.
1974	Rehabilitation of the remaining 400-ft section of the east pier (Figures 287 and 288) was completed. Repairs included two sheet-pile walls, granular fill, and a concrete superstructure (similar to previous rehabilitation of the structure). Repairs to the west pier, also performed during this year, consisted of the placement of riprap stone on the lakeside of the structure. The stone ranged in weight from 400 lb to 2 tons and extended to the lwd el.

1976	A 400-ft-long section of the east breakwater (immediately east of the east pier) was repaired using stone fill and recapping the structure with concrete. Stone was also placed on the lakeside of the breakwater in this location.
1978	Repairs to the west pier were performed which included placing fill stone in portions of the pier and capping the structure with concrete. Riprap was also placed along the channel side of the pier. Riprap stone ranged in weight from 250 to 500 lb.

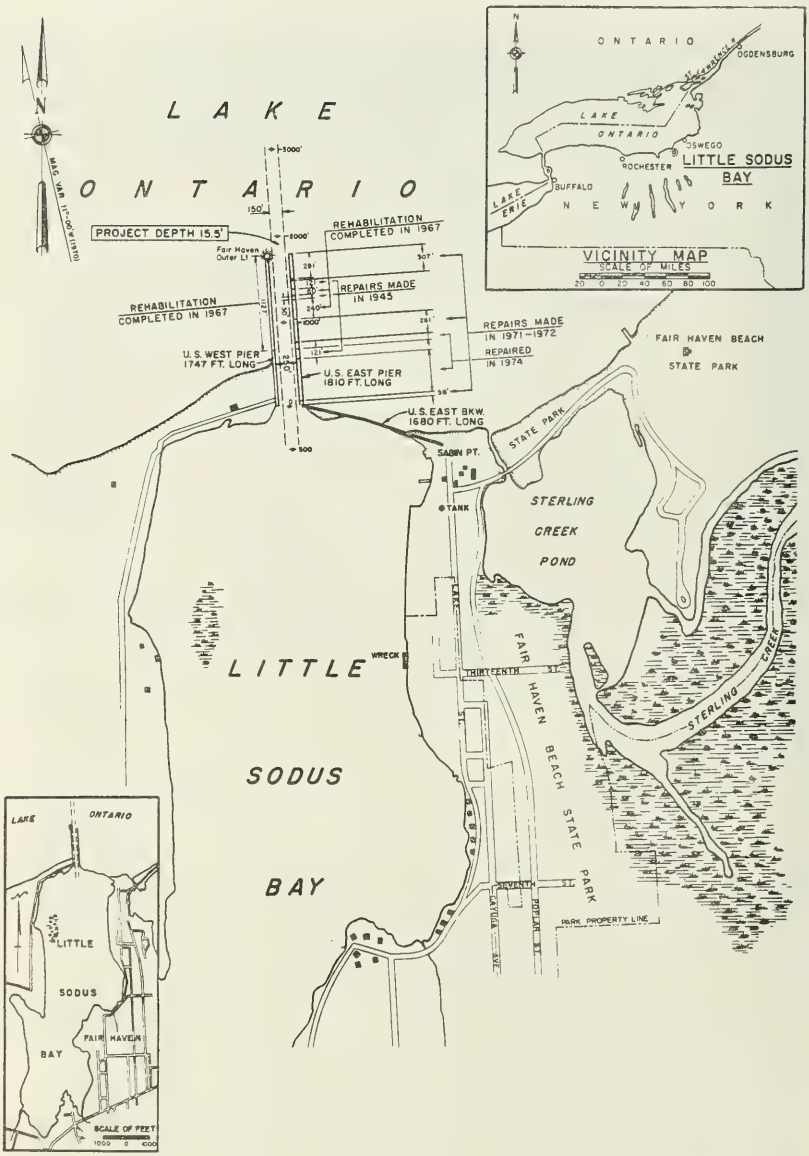
Figure 290. Little Sodus Bay Harbor, New York

1986	During their lifetime the entire east and west piers have been rehabilitated. There is no record of repairs to the west breakwater; however, the concrete cap is currently spalled and cracked in many locations. Presently the structures are considered to be in fair condition.

1967	Repairs to 300 ft of the east pier and 1,127 ft of the west pier (Figure 290) were completed. They included encasing the existing structures with steel sheet-pile walls, filling the voids between the new sheetpiling and the existing pier with granular fill, and capping the structure with concrete (Figure 291). The crest el of the east pier was +8.3 ft lwd, and the west structure had an el of +8.7 ft lwd.
1971-1972	Rehabilitation of another 626 ft of the east pier (Figure 290) was completed. Repairs were similar to those completed in 1967 (Figure 291).
1974	Remaining portions of the east pier (those not rehabilitated at an earlier date) were repaired (Figure 290). Rehabilitation consisted of similar construction methods used in earlier repairs which included steel sheet-pile walls, granular fill, and concrete caps (Figure 291).
1978	Repairs to the shoreward 620-ft-long portion of the west pier were completed (Figure 290). Rehabilitation consisted of encasing the existing pier with steel sheet-pile walls, installing granular fill in the voids between the new walls and the old timber crib, and pouring a concrete cap.
